BUILDING SURVEY REPORT
OF
MELKSHAM ASSEMBLY HALL
MARKET PLACE,
MELKSHAM, SN12 6ES
5 FEBRUARY 2020

Prepared By:

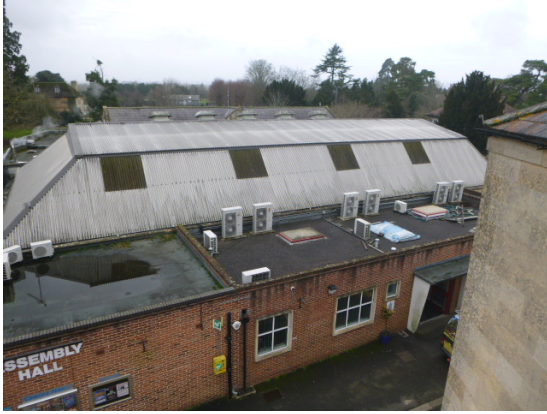
1. Front elevated view of the Assembly Hall and roofs.

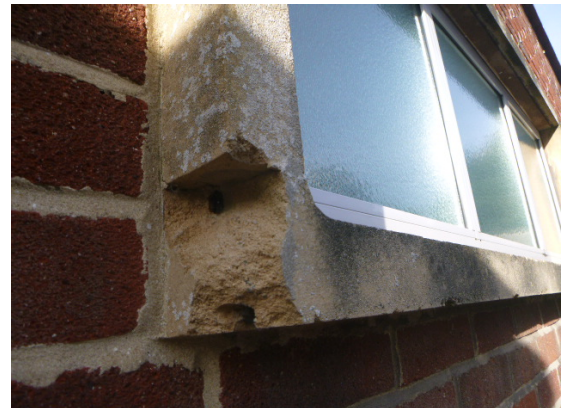
4. Spalling reconstituted stone window surround with corroding rebar.

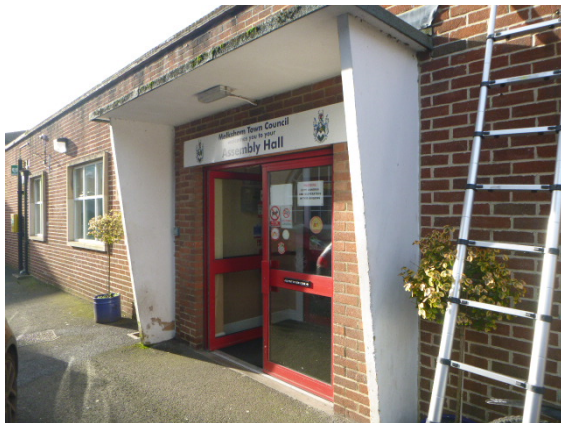
5. Main front door with level access.

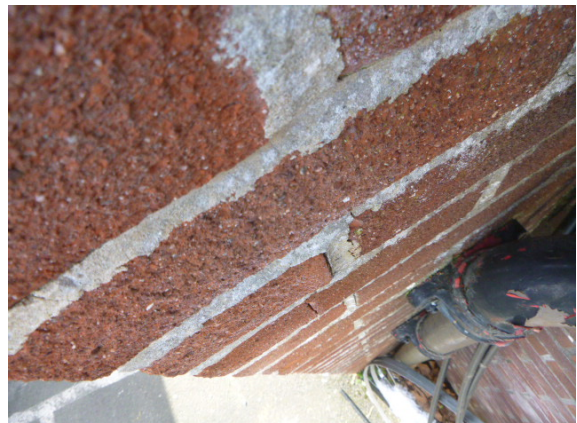
6. Expansion crack along the front elevation.

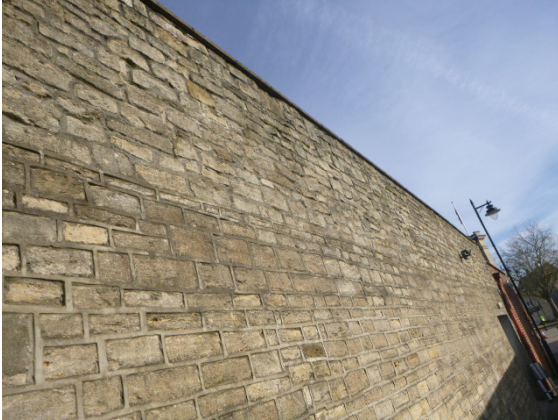
7. View of the left side elevation with rubble stone and coping a top.

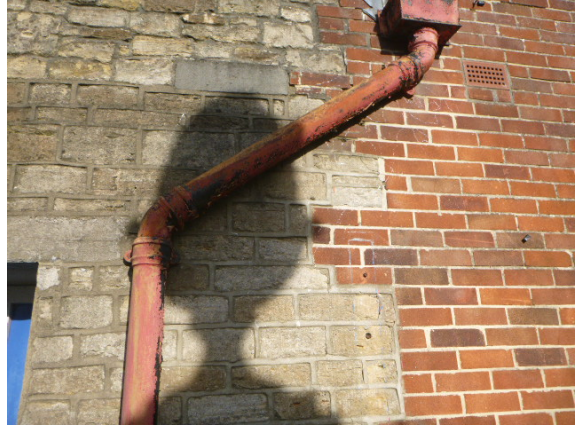
8. Brick to stone junction along the left elevation and failing décor to the cast iron downpipe hopper.

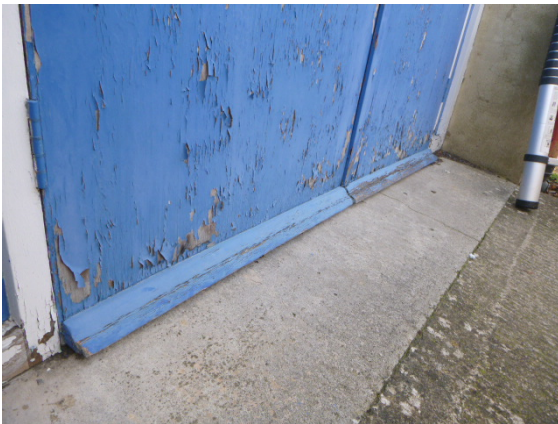
9. Side fire exit doors in poor repair.

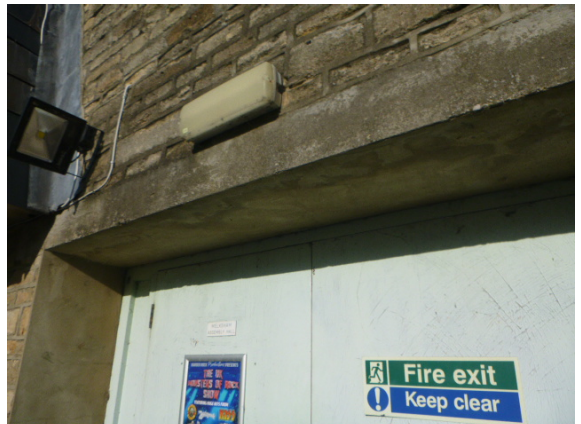
10. View of the fire exit door heads with rain tracking under the lintel and staining the finish.

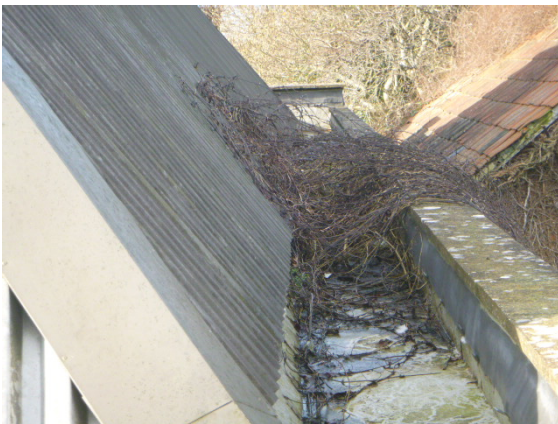
11. View of the rear parapet gutter run – heavy vegetation growing and blocking the ability of the gutter.

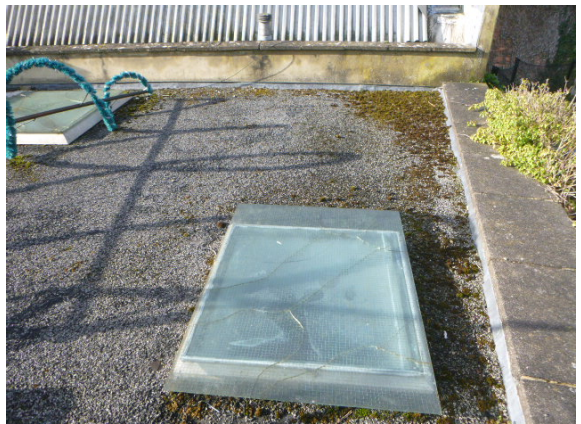
12. Cracked Georgian wired roof lights over the Dressing Rooms.

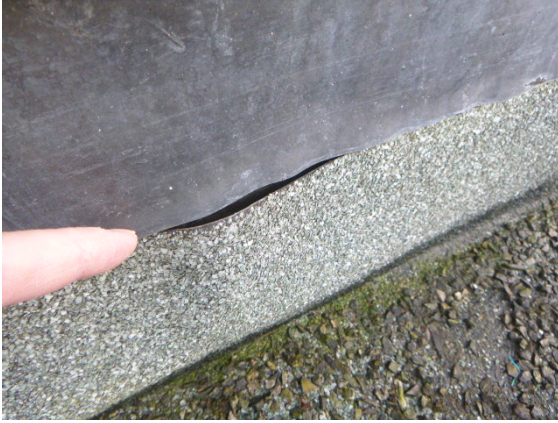
13. Typical workmanship failure of the flat roof felt upstand and lead flashing allowing rain to penetrate behind.

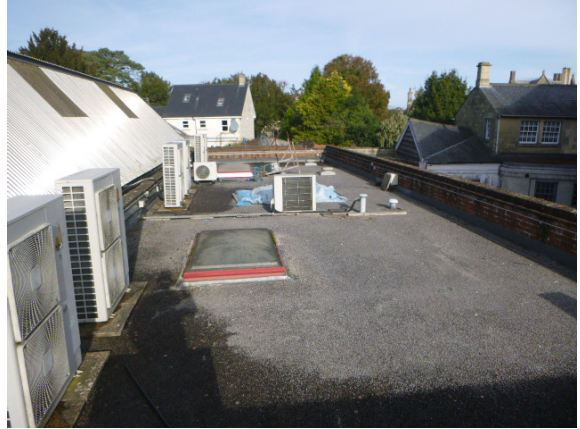
14. View across the flat roofs serving the frontage.

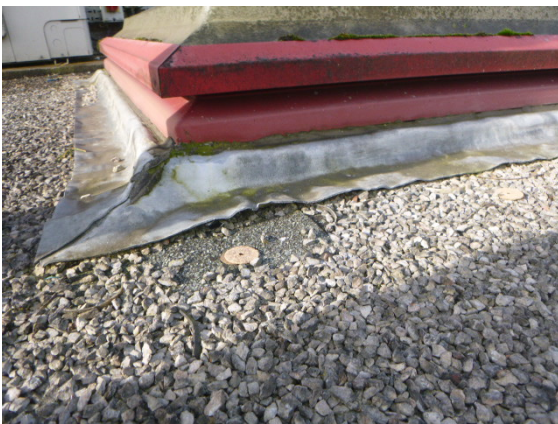
17. Lead upstands to office / foyer rooflights split and inadequately detailed reflect continuing leaks.

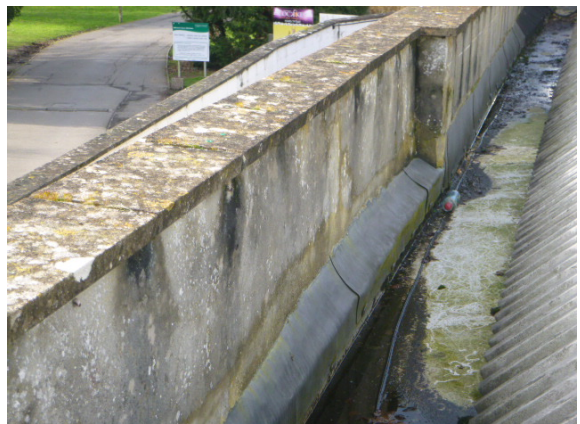
18. Crude lead flashing details and hollow render to the left side parapet. Parapet gutter noted to be offering minimal gradient. Copings lose requiring rebedding (H&S risk).

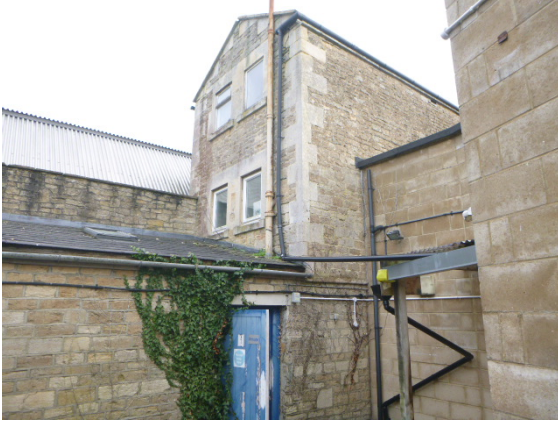
19. Rear arrangement with older redundant stone central core above.

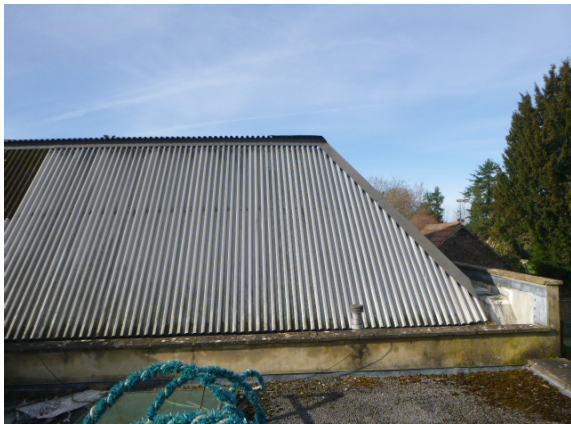
22. Wall mounted air conditioning unit. 2nr serve the offices.

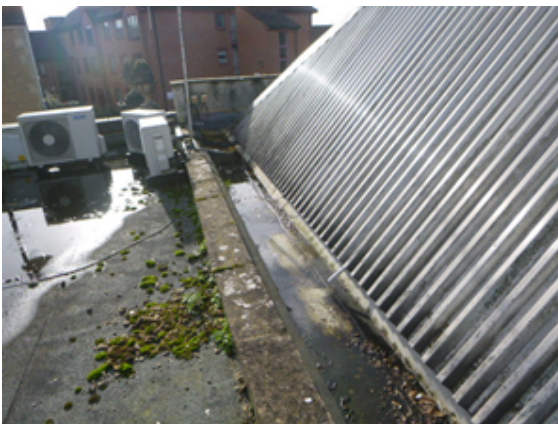
23. Metal pitched roof to the Hall, parapet gutter and loose copings.

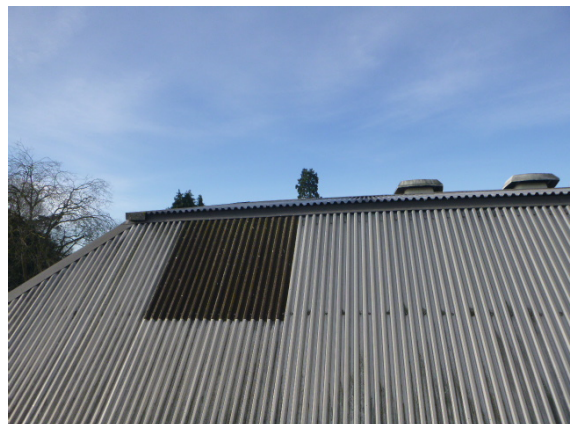
24. GRP roof light to the metal clad roof.

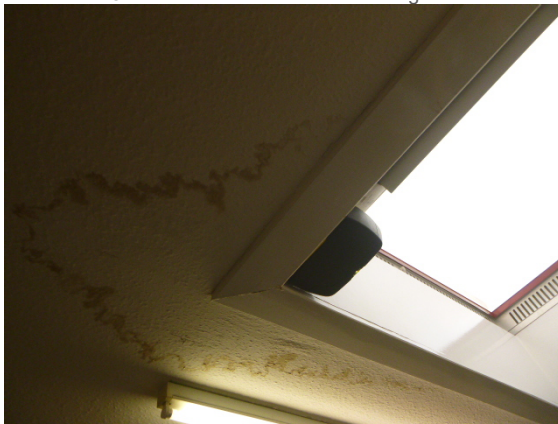
27. Staining of the office ceiling due to roof light leakage.

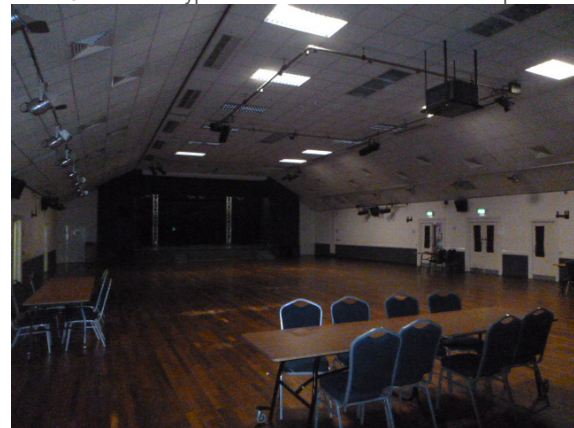
28. Further view of the main hall and floor finish.

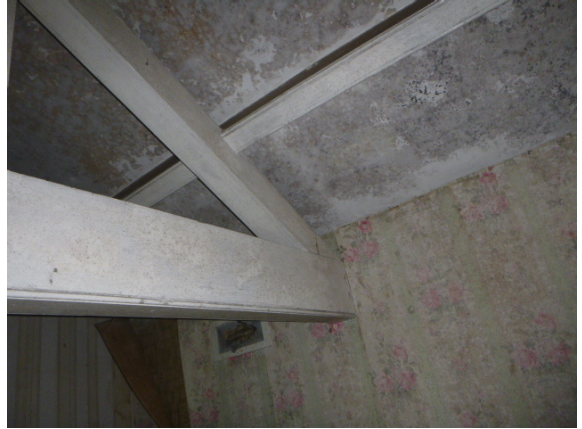
32. King post trusses embedded in the solid wall of the older section of the central core – prone to wet rot.

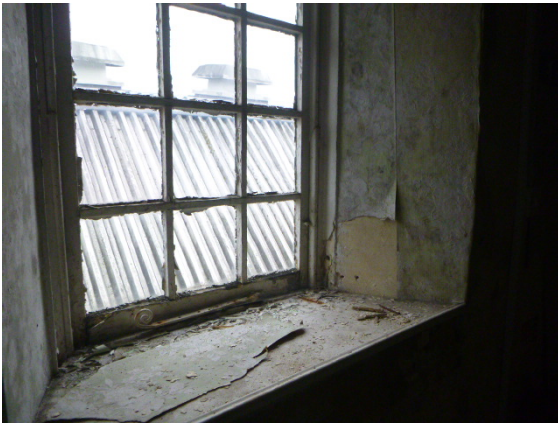
33. Typical old neglected window to the central core section upper floors. Looking towards the rear clad pitched roof slope.

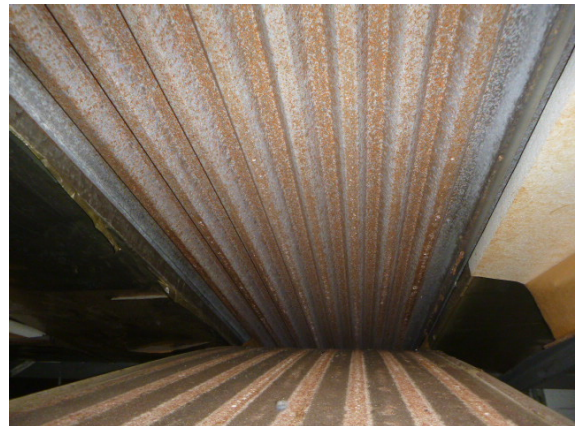
36. Loss of adhesion to the insulation panels beneath the clad roof of the assembly Hall plus corrosion due to moisture run off.
