CONDITION SURVEY REPORT

in respect of

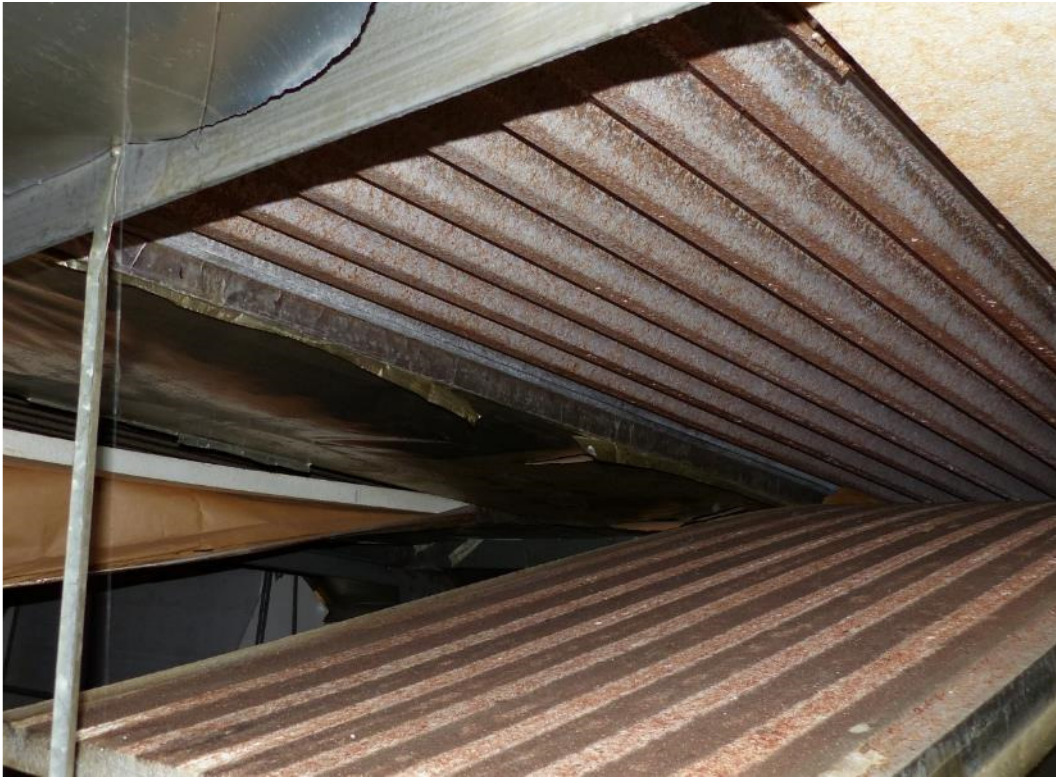
Photograph 11: Corrosion to underside of the aluminium roof cladding. The orange staining is the adhesive for the polystyrene insulation that has become de-bonded.

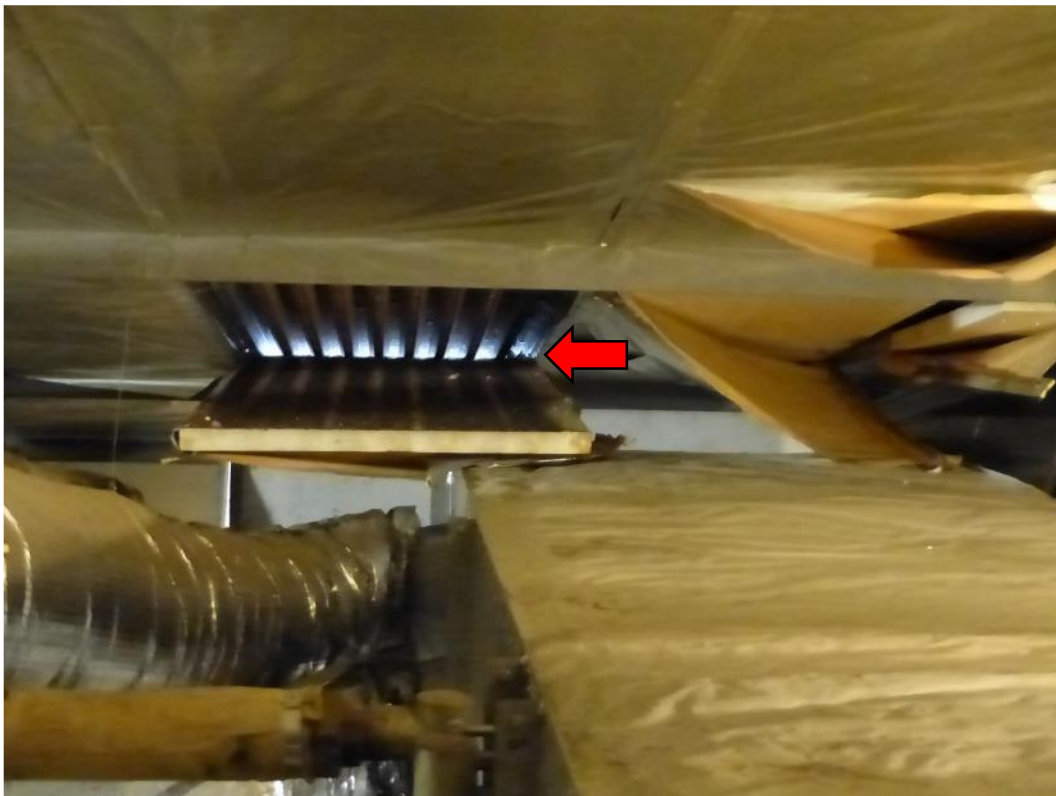
Photograph 12: Light entering the roof void at the exposed knee joint of the main hall mansard roof.

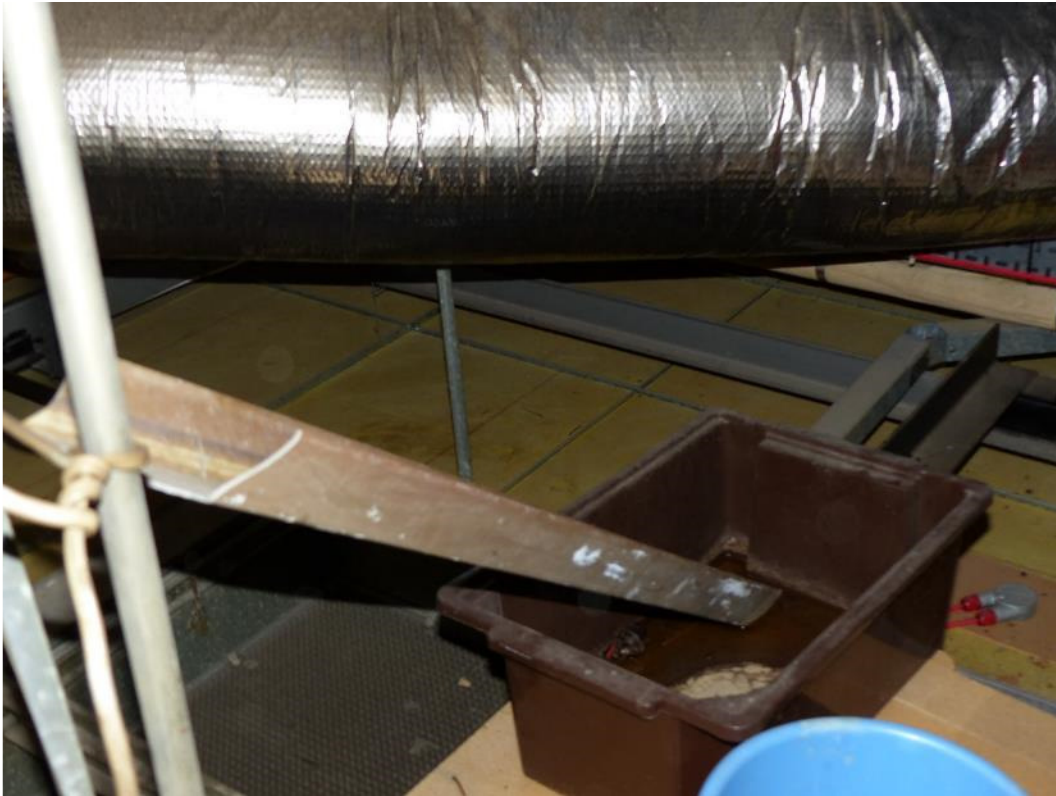
Photograph 13: Makeshift gutter and bucket collecting water from roof leaks over the main hall.

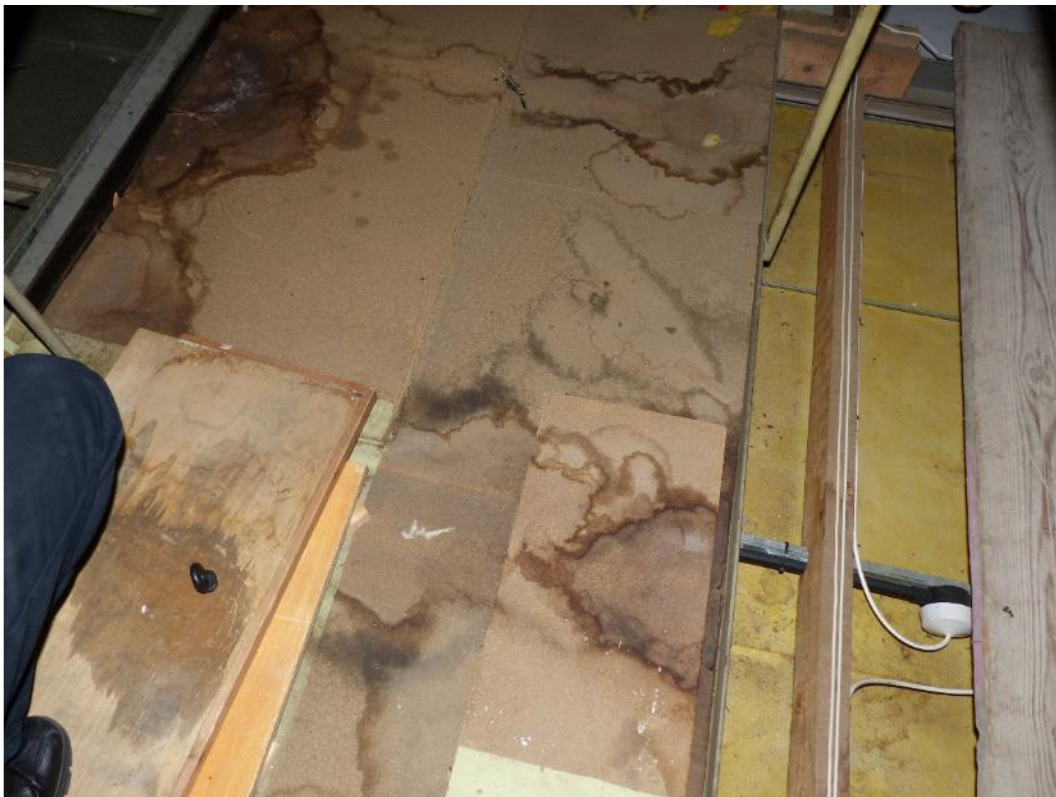
Photograph 14: Water stained boarding to the roof void walkway and additional boards represent a trip hazard.

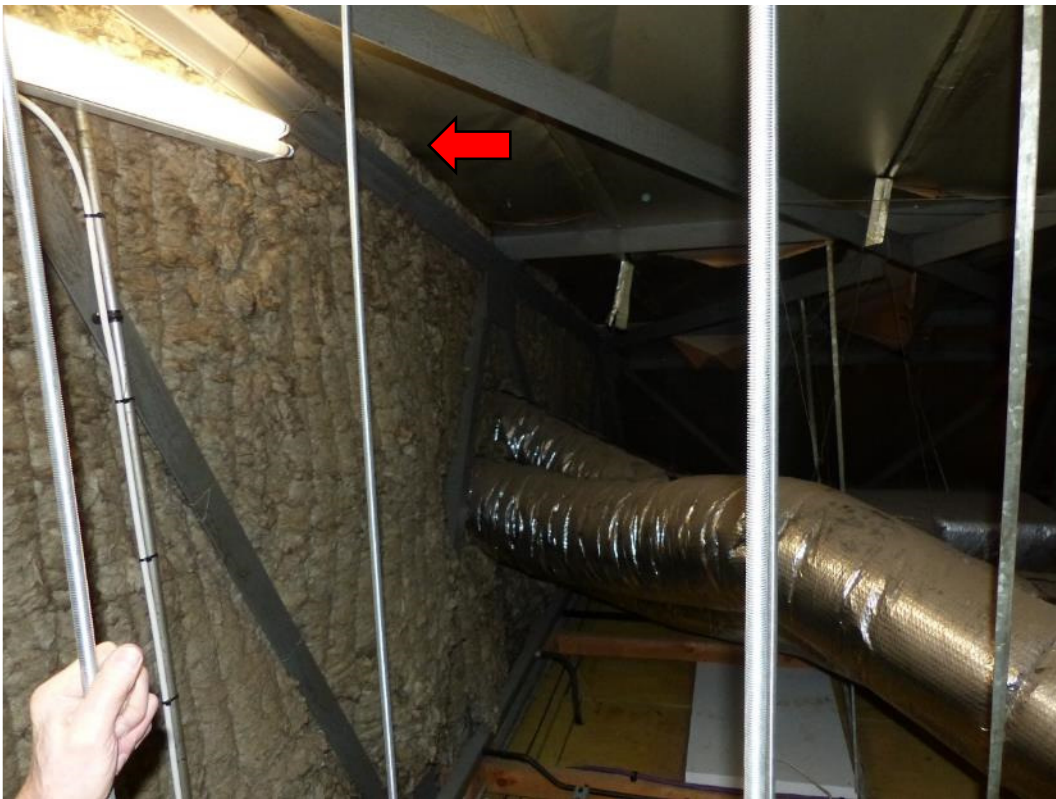
Photograph 15: Fire barrier apparently fixed below the polystyrene insulation and no obvious dampers to the ducts passing through it.

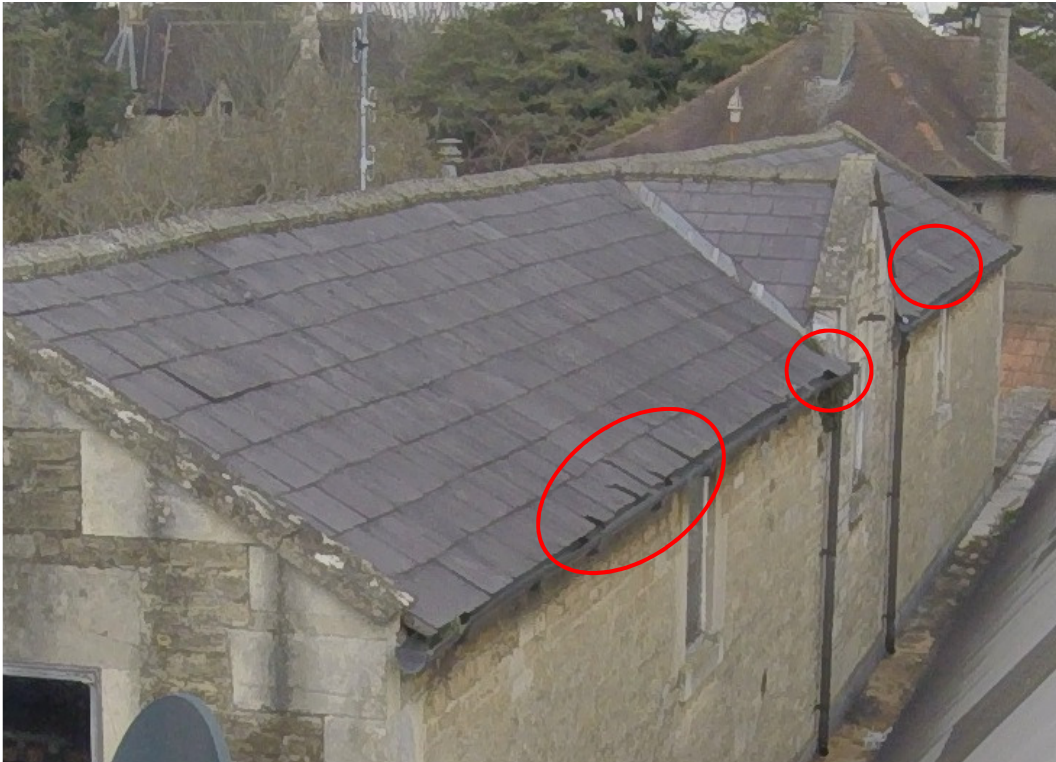
Photograph 21: Slipped and damaged slates to the front roof slopes three storey section.

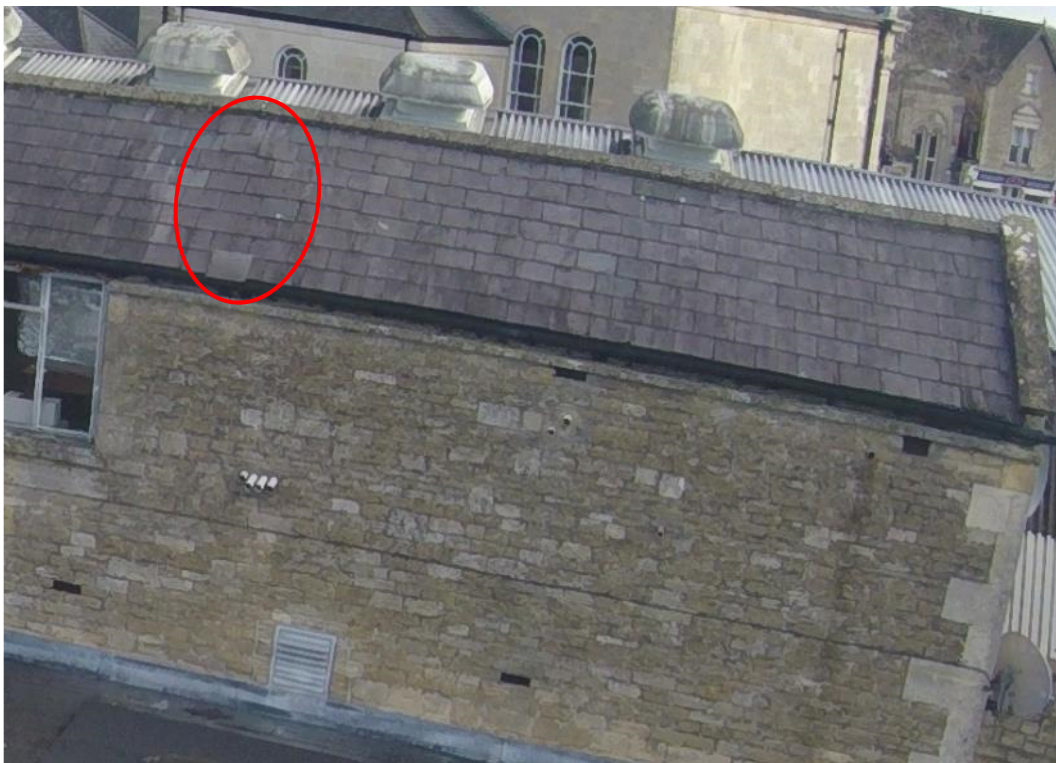
Photograph 22: Slipped slate to the rear of the three storey section.

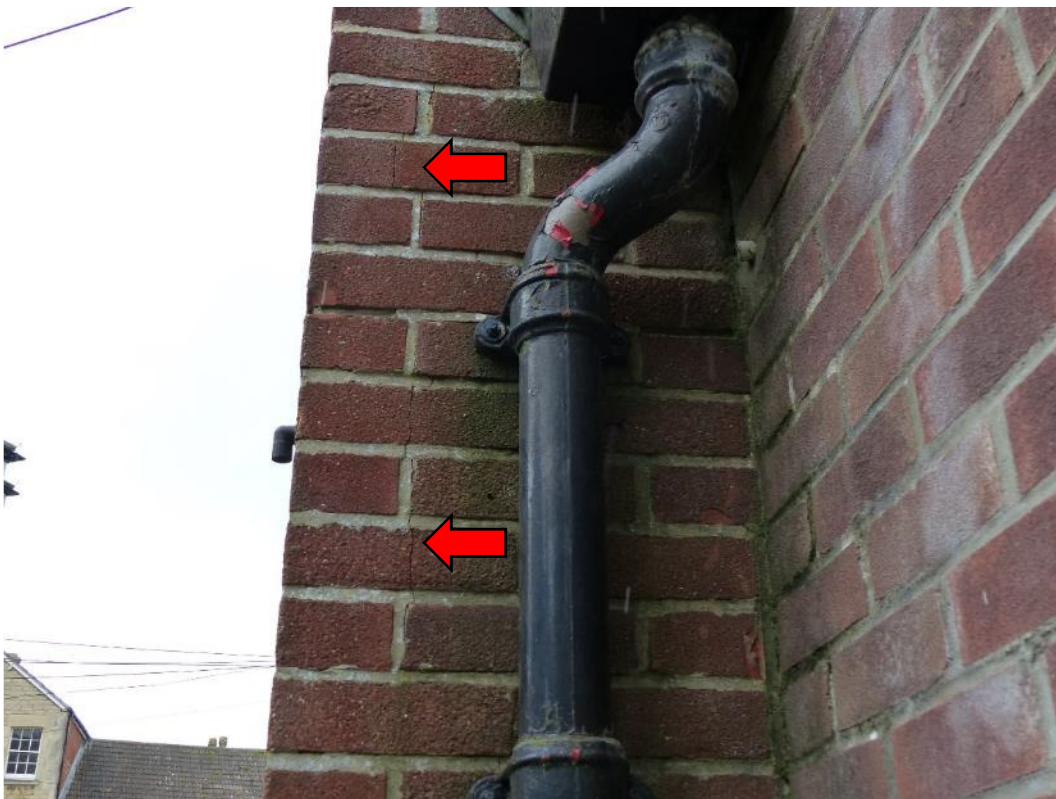
Photograph 32: Cracking to the set-back on the front elevation due to expansion of the brickwork.

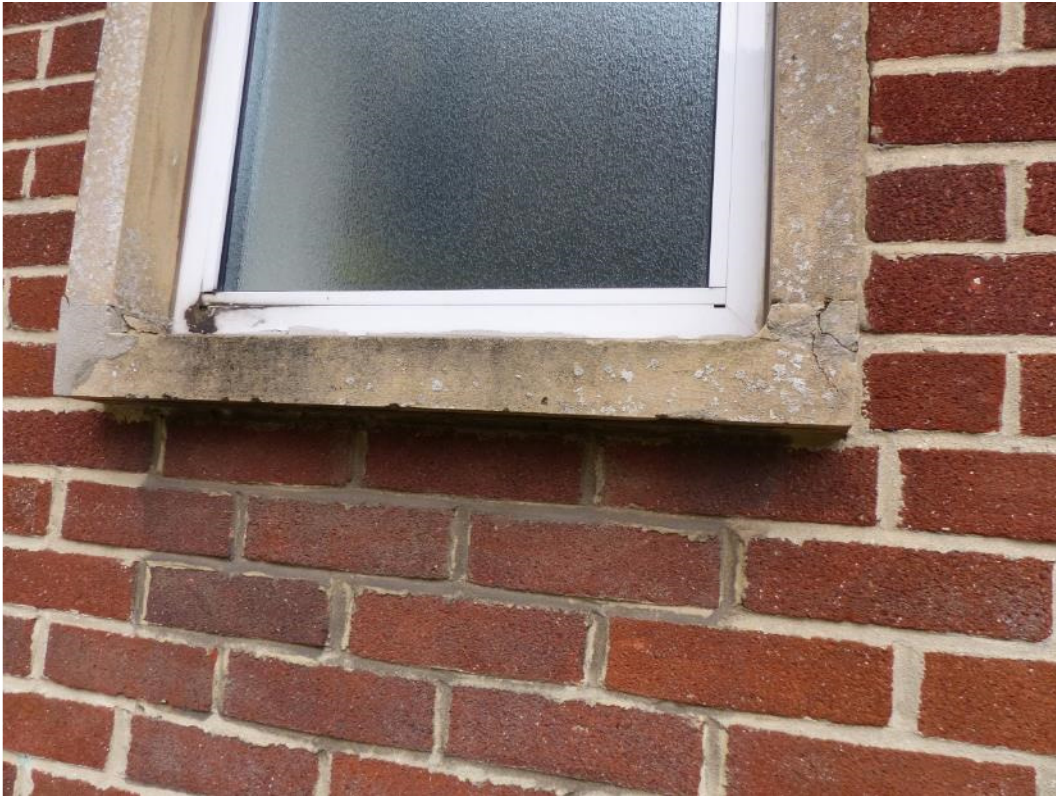
Photograph 33: Cracking and patch repairs to the corners of the front window surrounds.

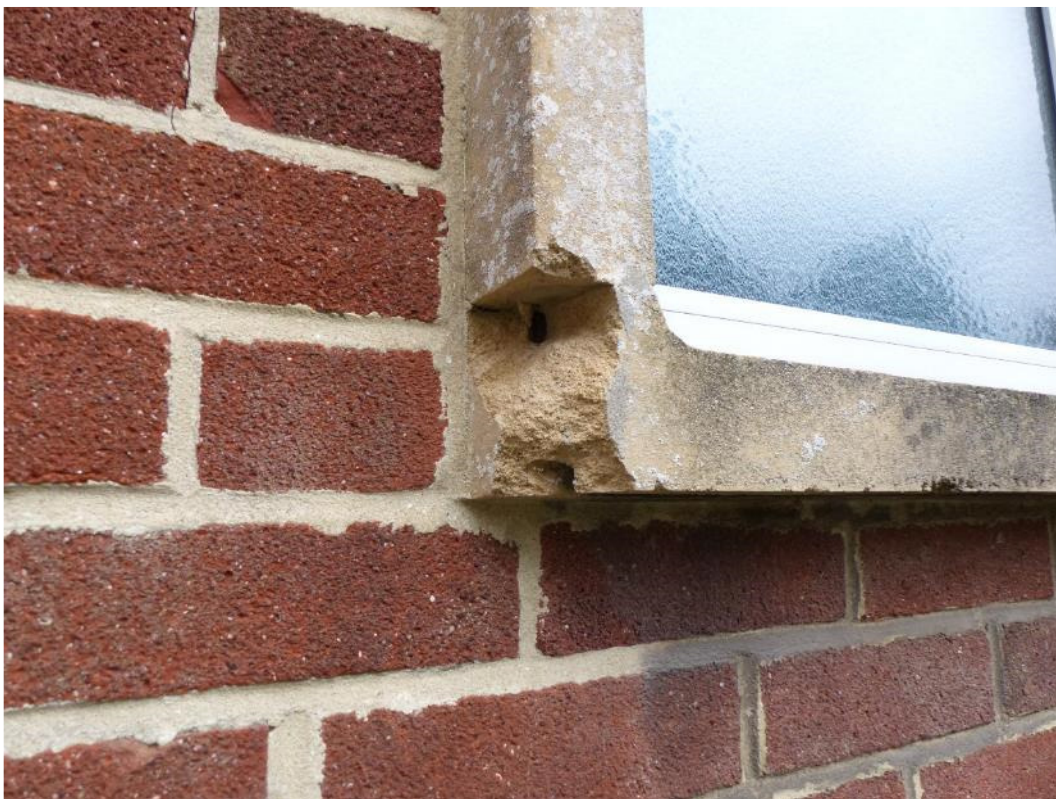
Photograph 34: Spalling to the front window surrounds

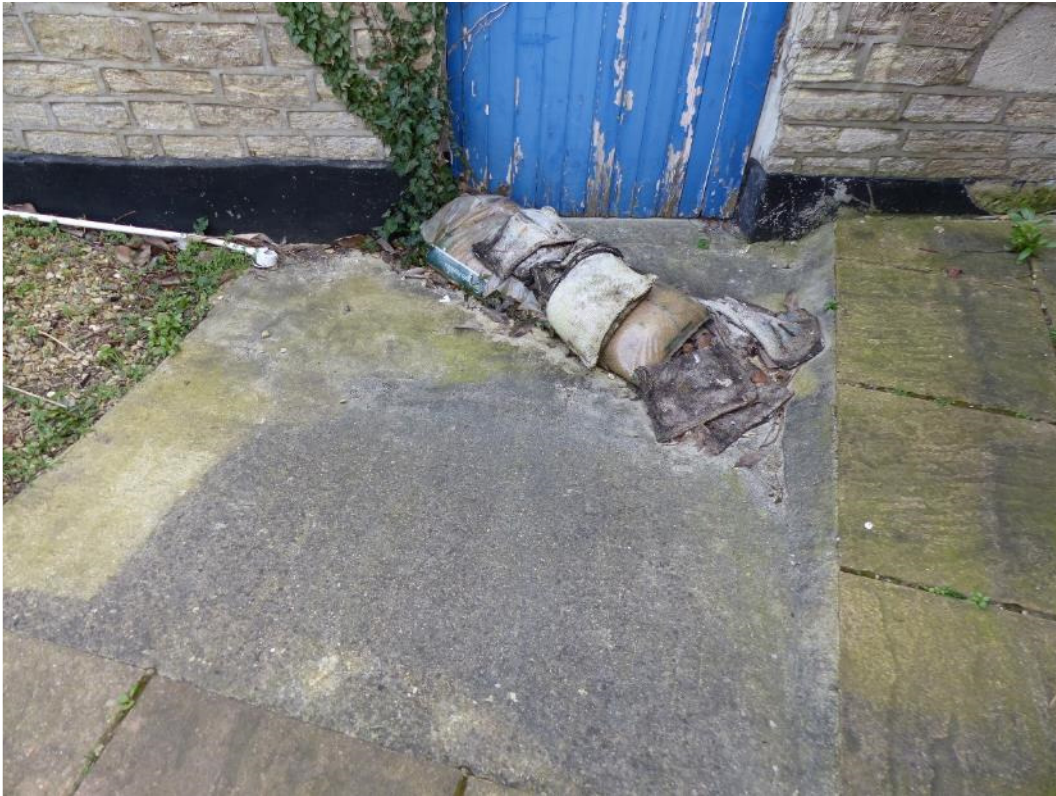
Photograph 35: Well area and sand bag outside the rear right hand fire exit door.

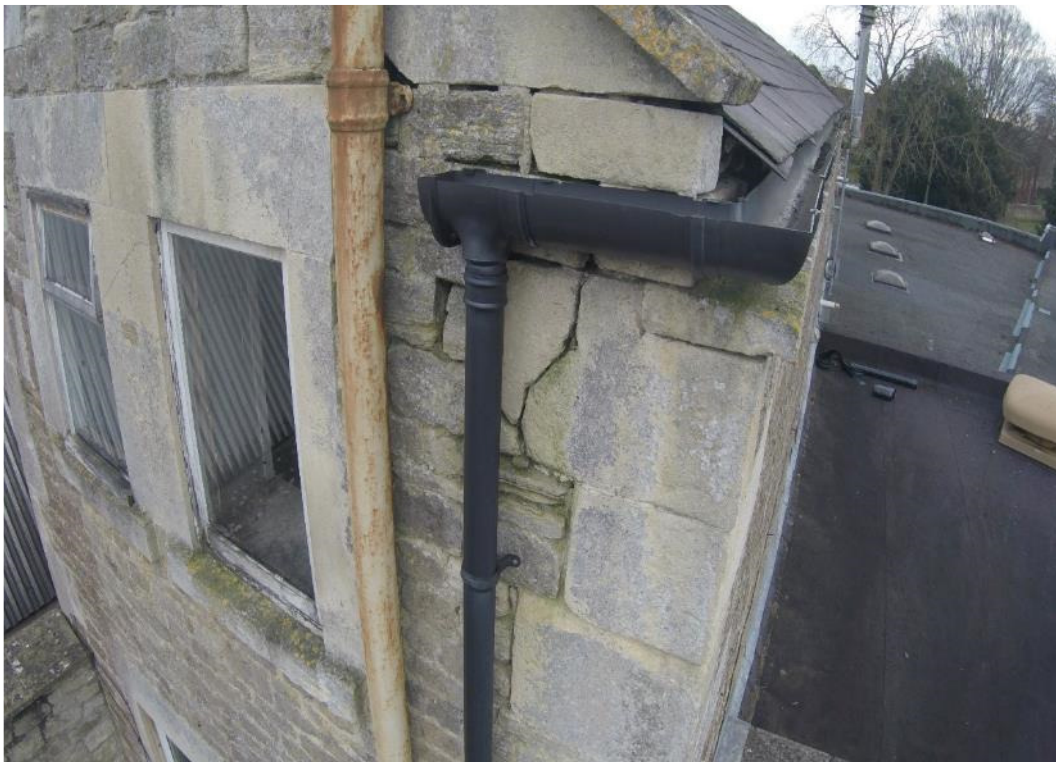
Photograph 36: Cracking and poor pointing to the rear right hand corner of the three storey section.

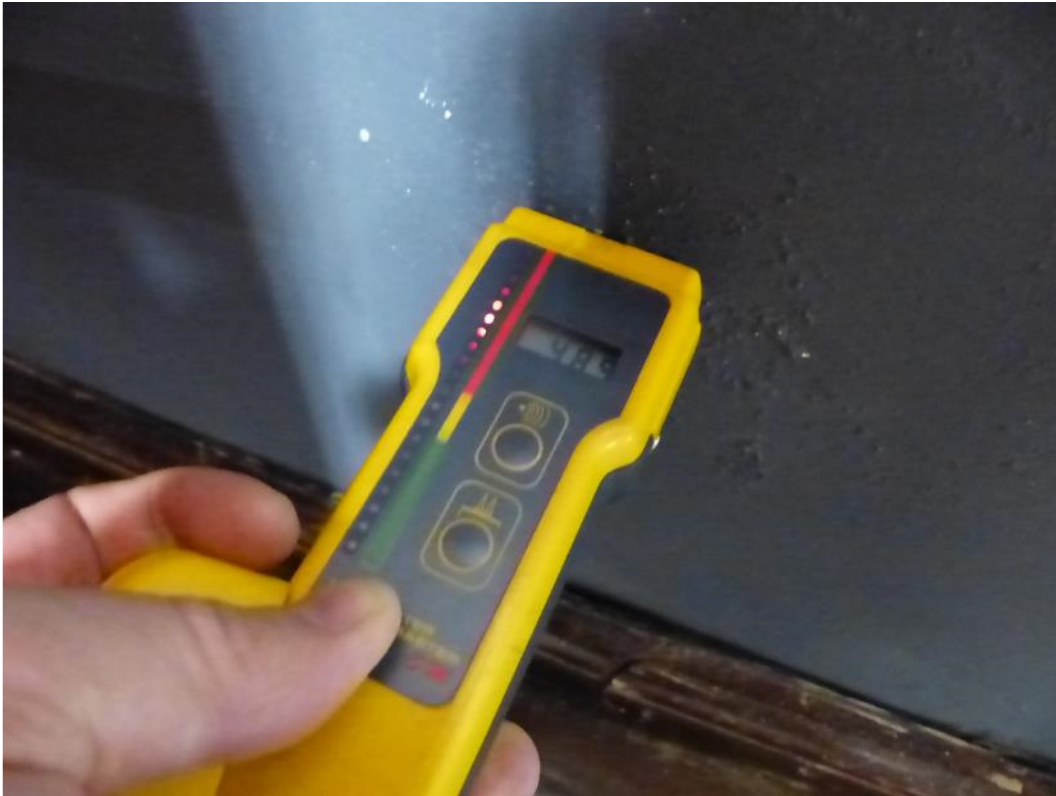
Photograph 37: Dampness to the left hand side of the rear wall of the main hall at low level.
